**ASPHALT CEMENT CHIP SEALS  
IN OREGON**

**Construction Report**

**STATE RESEARCH PROJECT #546**

*Oregon Department of Transportation*

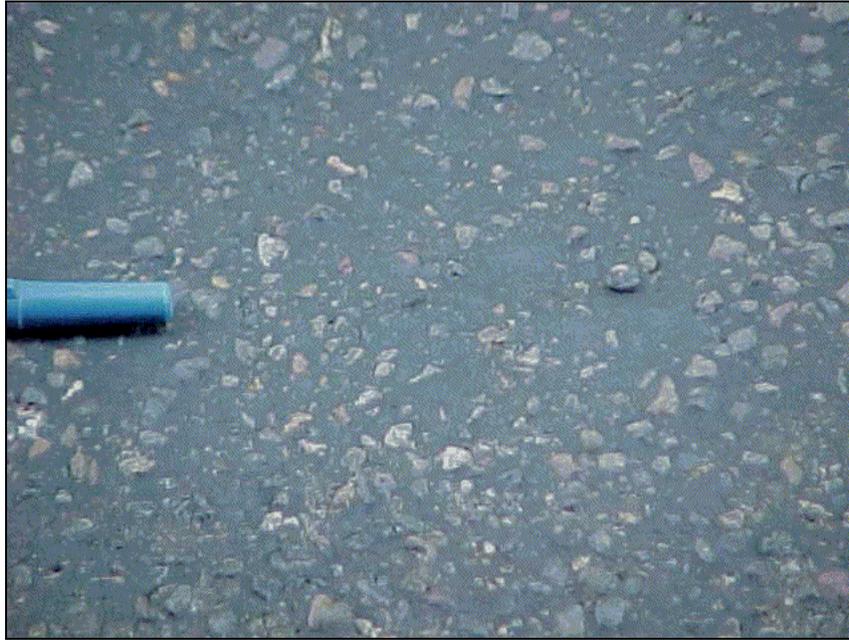
Figure 3.1: Close-up of Pavement Surface on OR Route 126

asphalt content between MP 13.0 and MP 16.0. In the previous year, this 4.8 km (3.0 mi) section had been sealed with an asphalt cement chip seal. However, because of dirty aggregate, most of the chips were stripped in the wheel paths soon after placement, leaving a heavy buildup of asphalt binder on the surface (Figures 3.1 and 3.2). As a result, skid resistance on the existing pavement had become a problem, and ODOT decided to apply another chip seal to increase skid resistance to acceptable levels.

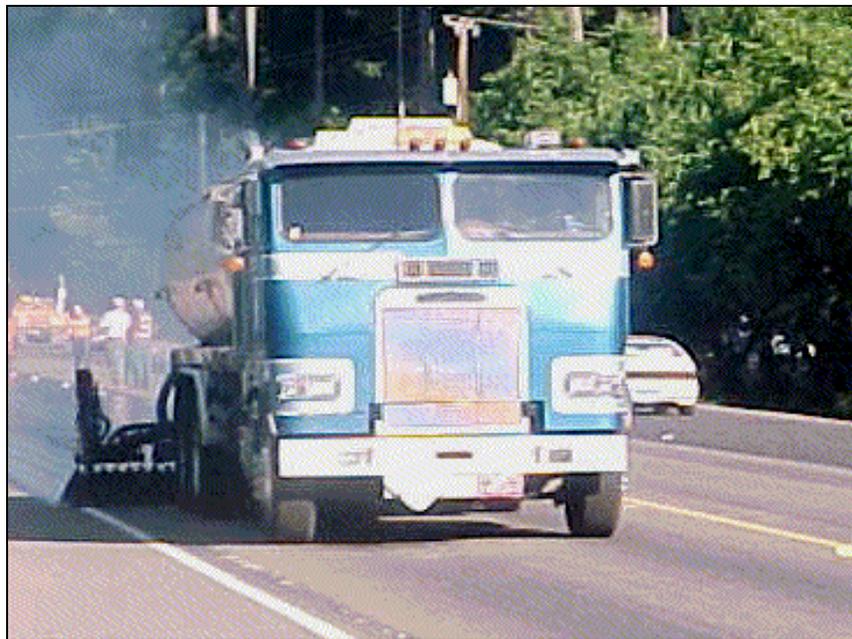
Figure 3.3: Asphalt Distributor Applying Asphalt Cement on OR Route 126

The asphalt cement was originally applied at 1.59 liters/m<sup>2</sup> (0.35 gal/yd<sup>2</sup>) and later reduced to 1.50 liters/m<sup>2</sup> (0.33 gal/yd<sup>2</sup>), shown in Figure 3.3. The chips were 9.5 mm to 6.3 mm (3/8" to 1/4") in size. The chip application rate was 9.2 kg/m<sup>2</sup> (17 lbs/yd<sup>2</sup>). Lane County's chip spreader was self-propelled and equipped with computerized controls that adjusted the opening and closing of gates based on the speed of the spreader (Figure 3.4).

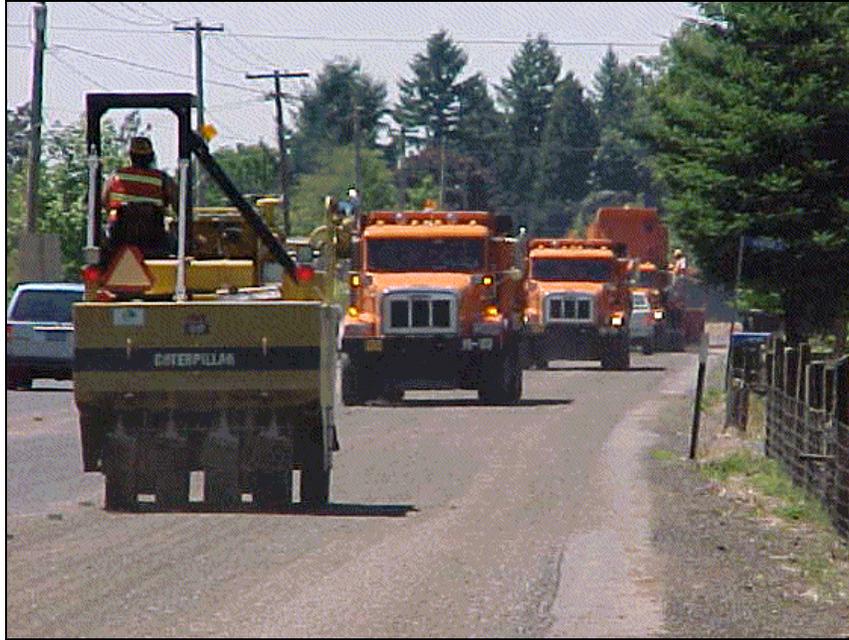
Figure 3.5: Pneumatic Roller Operating Behind Dump Trucks

During construction, the chips were usually placed within one minute after the asphalt cement was shot. The rollers were operating behind the trucks hauling the chips, so it took from one to several minutes for the rollers to reach the chip sealed section (Figure 3.5). Haul trucks traveled behind the chip truck and provided the initial compaction. The trucks were also staggered across the panel in order to compact as much of the chip seal as possible (Figure 3.6). After the panel was rolled, it was watered to cool it and then swept with the rotary sweepers.

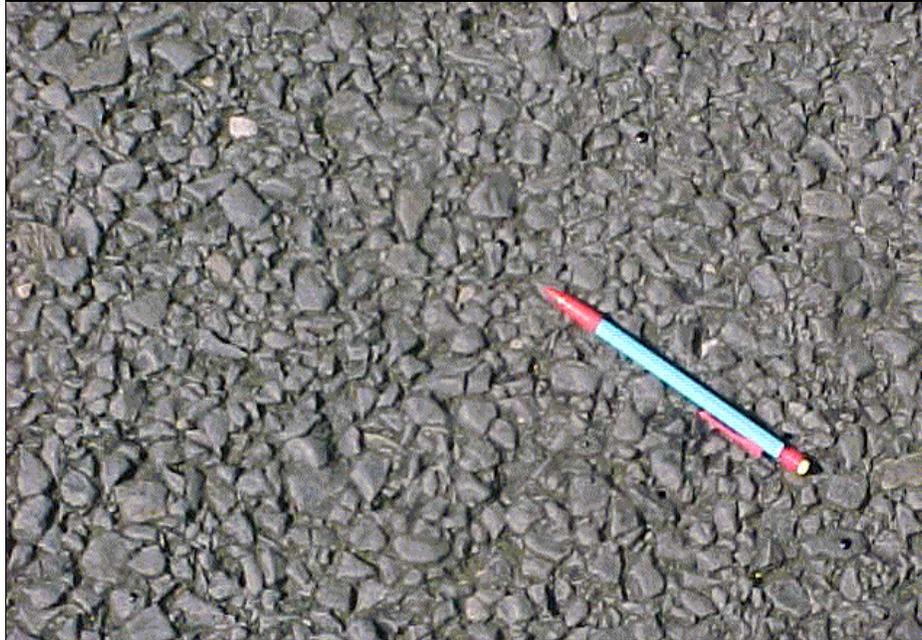
Figure 3.7: Close-up Image of Open Graded Pavement on U.S. Route 101; MP 130.0

U.S. Route 101, from MP 129.0 to MP 130.2 was chip sealed on September 16, 1999. The ADT of this section is 18,500. The existing wearing surface was an open graded asphalt pavement, constructed in 1993. The aggregate had become very polished, and in some areas, there was moss growing in the voids (Figure 3.7). This section of U.S. Route 101 had a history of low skid resistance and several accidents. Throughout the project area, there were shady and sunny areas (Figure 3.8). Within this section is a hill with a horizontal curve at the crest.

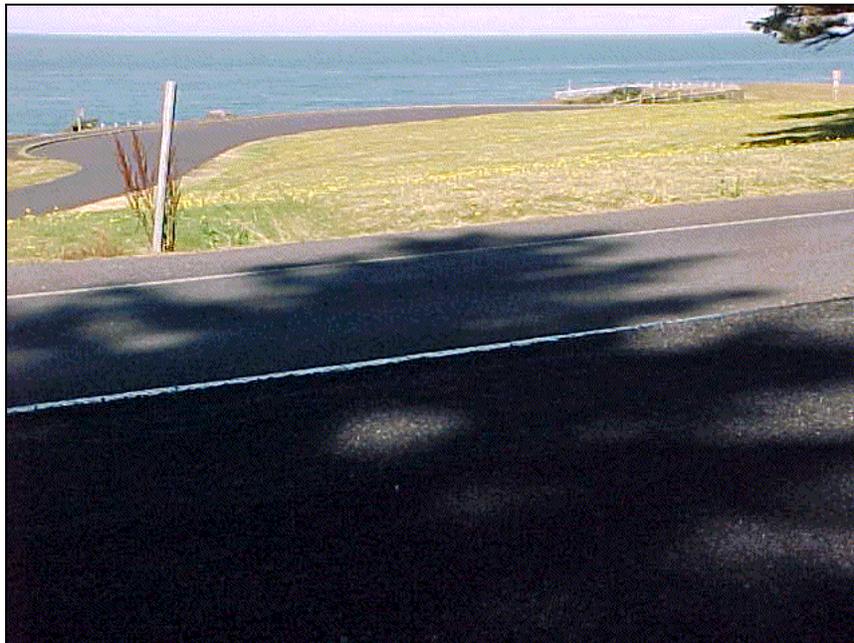
Figure 3.8: U.S. Route 101 at MP 130.0 with the Pacific Ocean in the Background

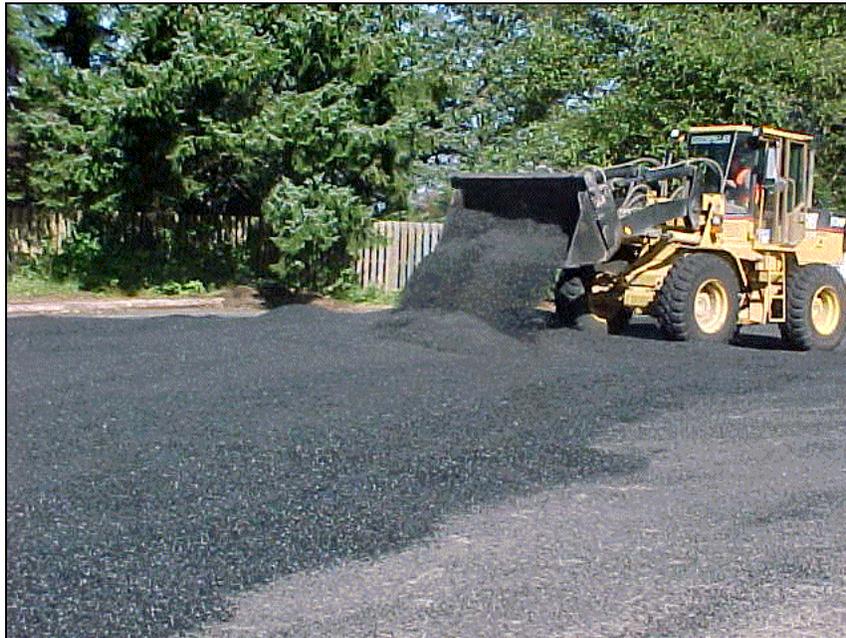
Figure 3.9: Stockpile of Precoated Chips Being Levelled and Turned Over to Cool

Due to traffic and temperature considerations, the chip seal construction did not start until after 9:30 a.m. The first section completed was in the turning lane of U.S. Route 101 at about MP 130.2. The pavement surface appeared very tight with loose chips throughout. Construction required multiple passes of the spreader to get the chips out, as they were sticking together and not evenly distributed. An inspection of the stockpile revealed that the chips were still warm  $>35^{\circ}\text{C}$  ( $95^{\circ}\text{F}$ ). The chip stockpile was moved around in an attempt to cool off the chips (Figure 3.9). The chips also appeared to stick together because of a heavy coat of asphalt. Samples were collected for testing. The actual asphalt precoat amount, determined by incineration at the ODOT Materials Laboratory, was 1.70%, almost three times the target. Gradation and tests for fracture however, conformed to specification requirements. The results of incineration testing, and other lab testing for the precoated aggregate are contained in Appendix B.

After about an hour of moving the chips, the decision was made to proceed, and the sections were built with one truckload of chips at a time. By controlling the chip delivery rate, workers were able to cover light spots with aggregate by raking or spreading with a shovel (Figure 3.10). In other areas, the chip application was much higher than the target of  $10 \text{ kg/m}^2$  ( $18 \text{ lbs/yd}^2$ ).

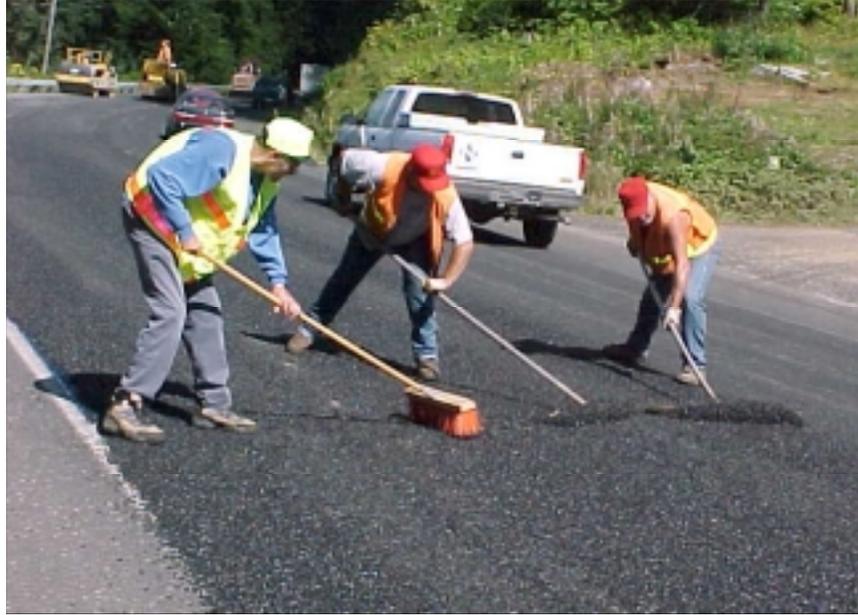
Figure 3.10: Workers Spreading Chips Across the Mat to Ensure a Uniform Application

Controlling the chip application rate in spite of the clumping may have been possible with a newer chip spreader. The chip spreader used was reported to be somewhat outdated. Newer spreaders allow a computerized application rate to be set and more flexibility in opening and closing selected gates.

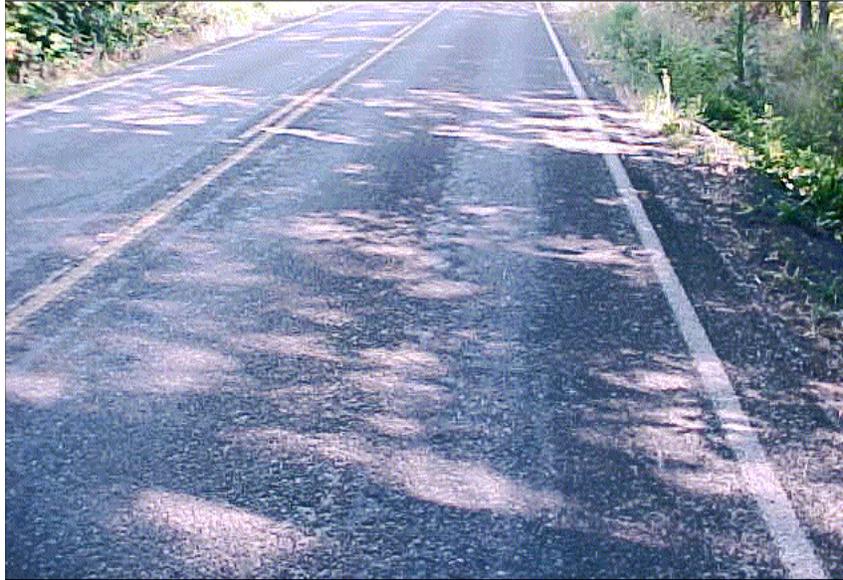
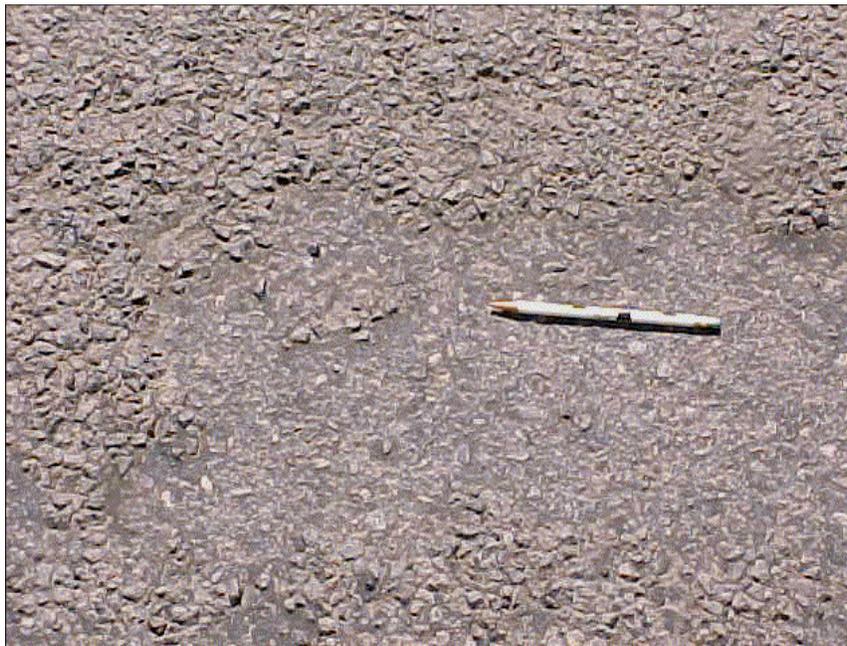
Figure 3.13: Foster Road Prior to Chip Sealing

On August 2, 1999 a chip seal was placed on Foster Road from the intersection of OR Route 212 to the Multnomah County Line. The ADT for Foster Road is 5,350. The section had been chip sealed three years earlier. The road was hilly and shady in some areas. No cracking was noted, however, chips were missing in several areas of the wheel path (Figures 3.13 and 3.14).

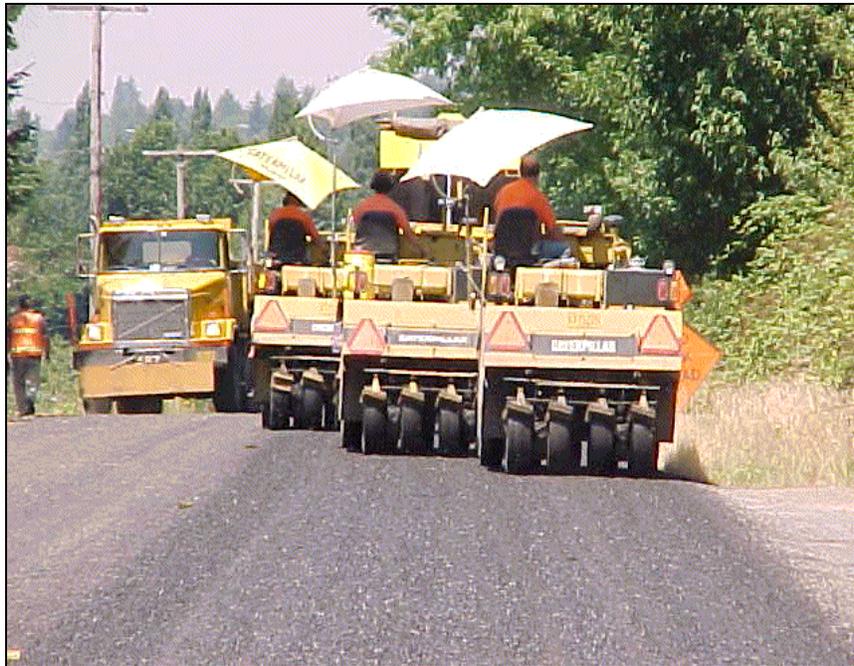
Figure 3.15: Staggered Pneumatic Rollers Operating to Ensure Maximum Coverage

The trucks and rollers staggered their passes to optimize chip embedment (Figure 3.15). The sections were covered with two to three roller passes. The steel drum roller was not on the job until 3:30 p.m. Delays were caused when the haul trucks could not keep up with the spreader. Additional delays were caused when the distributor truck had to be refilled.

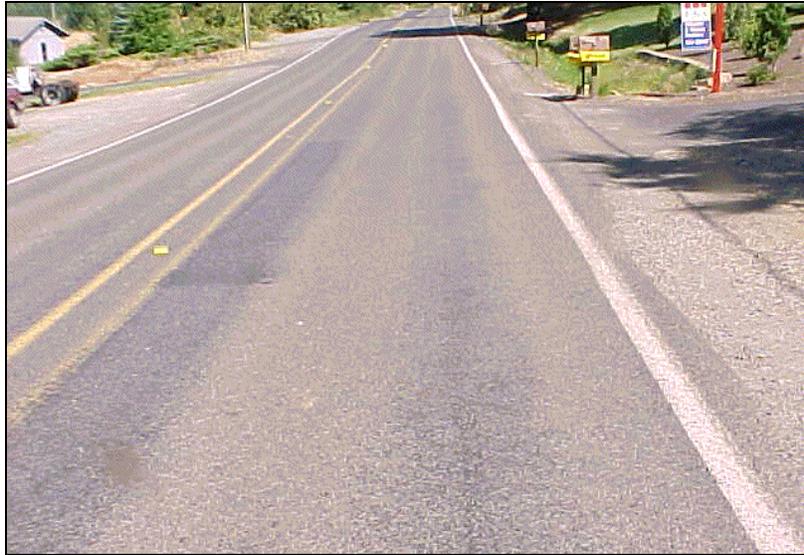
Figure 3.16: Sunnyside Road Prior to Chip Sealing

On August 3, 1999 a chip seal was placed on Sunnyside Road from the intersection of to OR Route 212 to 172<sup>nd</sup> Avenue. The ADT for Sunnyside Road is 37,200. The section was chip sealed three years earlier. The road was hilly and shady in some areas. No cracking was noted, however, chips were missing in the wheel path and in some areas the wheel path looked flushed (Figure 3.16).

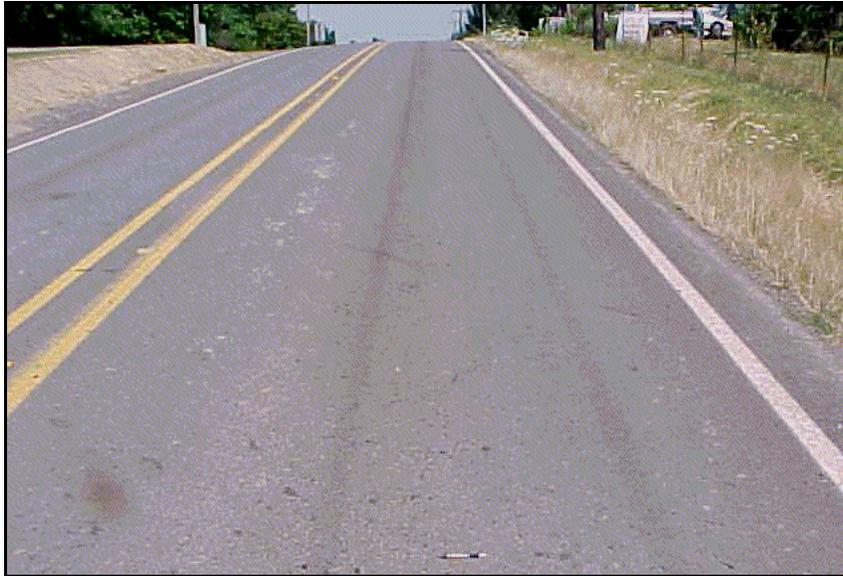
Figure 3.17: 232<sup>nd</sup> Avenue Prior to Chip Sealing

On August 4, 1999 a chip seal was placed on 232<sup>nd</sup> Avenue from the intersection of OR Route 224 to the intersection of OR Route 212. The ADT for 232<sup>nd</sup> Avenue is 5,050. The chip seal was being applied as a preservation treatment. The existing overlay was placed in 1992. The road was hilly and shady in some areas (Figure 3.17). No distresses were noted.

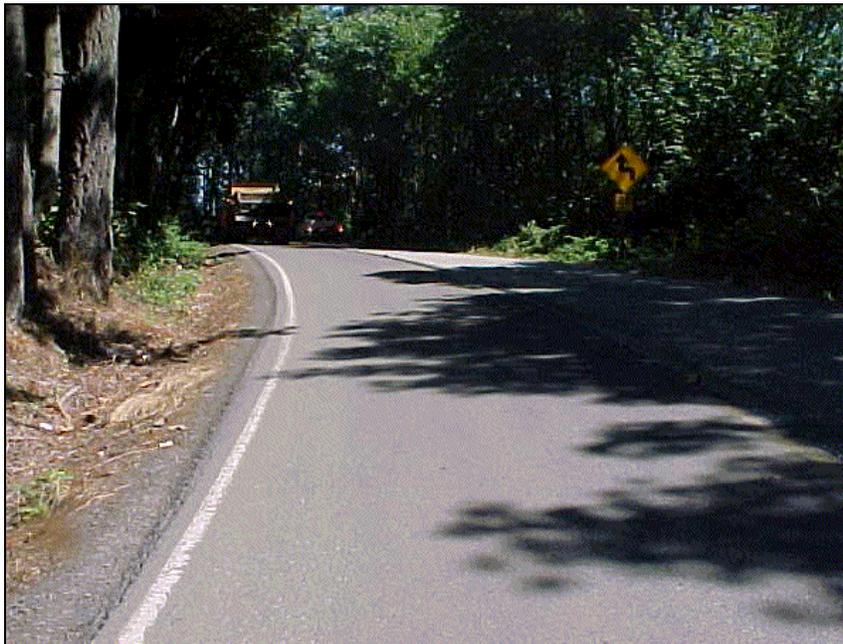
Figure 3.18: Wilsonville Road Prior to Chip Sealing

On August 17, 1999 a chip seal was placed on Wilsonville Road from the Yamhill County Line to the Wilsonville West City Limits (MP 4.52). The section was constructed with uncoated chips and then later fog sealed. The ADT for Wilsonville Road is 2,700. The chip seal was being applied as a preservation treatment. The existing overlay was placed in 1991. The road was hilly and shady in some areas (Figure 3.18). No distresses were noted.

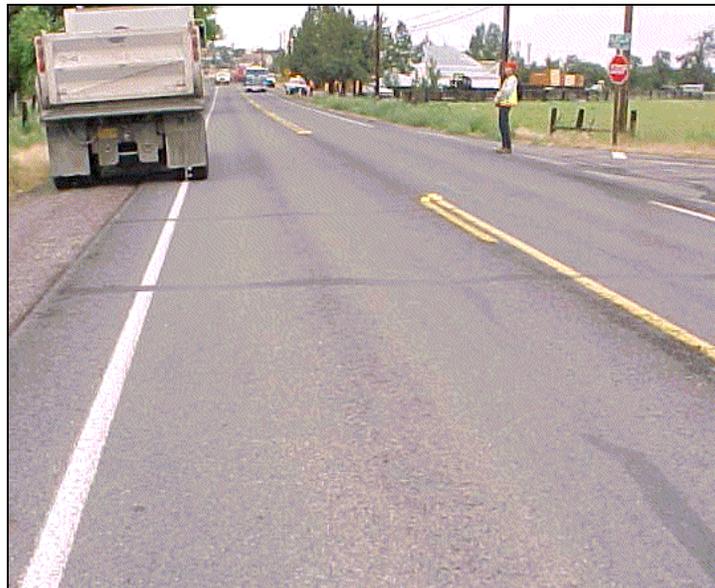
Figure 3.19: Canal Boulevard Prior to Chip Sealing

Canal Boulevard has an ADT between 2,600 and 3,200. The pavement had been chip sealed previously and was due for another chip seal. There was some minor rutting and random transverse cracking on the pavement (Figure 3.19). In one section, there was alligator cracking in the left wheel path and full width transverse cracks.

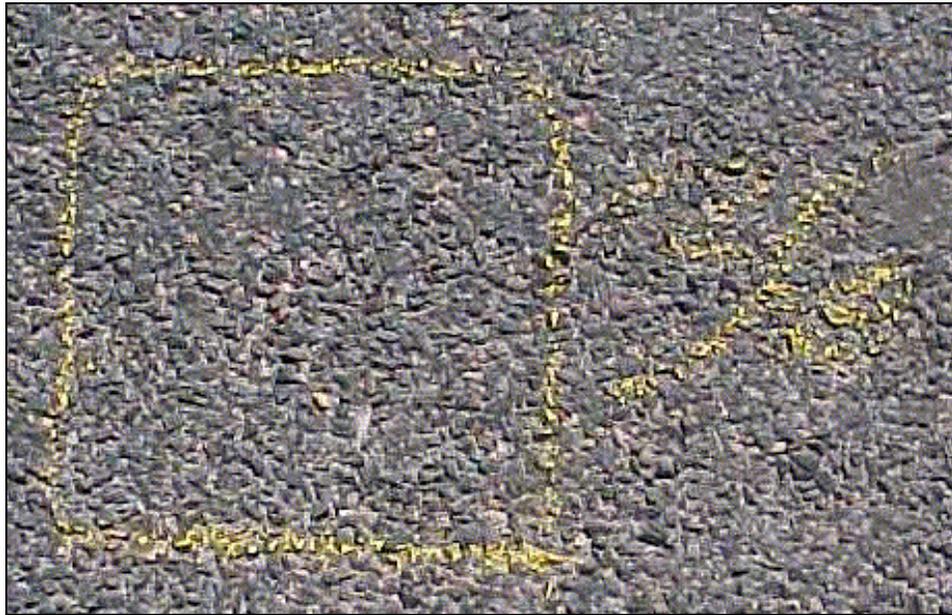
Figure 5.1: Image of the Pavement Surface on OR Route 126

Each asphalt cement chip seal test section was inspected approximately one month after construction. The purpose of the inspections was to visually examine the chip seal and establish a baseline for chip retention, chip embedment and the overall condition of the roadway. On each section, digital images were taken of the pavement surface. A 305 mm x 305 mm (1 ft x 1 ft) template was used to mark an outline on the pavement surface. The images were taken at approximately 0.4 km (¼ mi) intervals in the wheel path of each travel lane. Figure 5.1 and 5.2 are two of the close-up pavement images taken on OR Route 16 and U.S. Route 101 one month after the chip seal construction.

The position of each image was measured from a known point along the roadway and the information recorded in a database. Where each image was taken, a PK nail was driven into the pavement along the edge line to mark the site and the position was recorded in the database.

Overall, after being open for traffic for about one month, each section looked very good. Chip retention was over 90 percent on all sections. In addition, there did not appear any noticeable areas where pick-up had occurred.

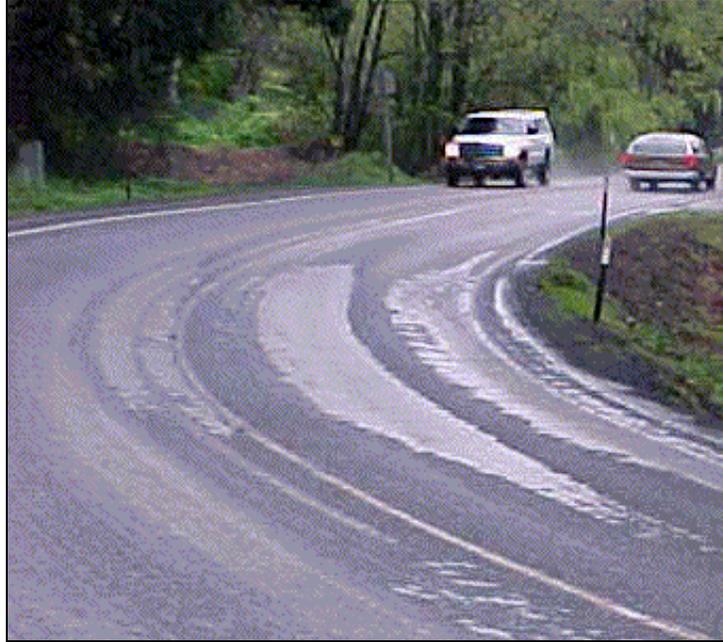
Figure 5.3: Loss in Chips in the Wheel Path near MP 30.0

In April 2000, ODOT District 5 maintenance personnel notified the Research Group about problems with the chip seal on OR Route 126 between MP 29.0 and MP 31.6. A meeting and on-site inspection was conducted on April 18, 2000. Between , MP 29.0 and MP 31.0, there were several locations where there was a significant chip loss in the wheel path. The condition was particularly conspicuous along curve sections (Figure 5.3).

There were several reasons suggested to account for the accelerated chip loss between MP 30.0 and MP 31.6. As discussed earlier in Section 3.1, the asphalt cement application rate between MP 26.0 and MP 31.6 was very low, 1.00 to 1.09 liters/m<sup>2</sup> (0.22 to 0.24 gal/yd<sup>2</sup>). With the low shot rate, there was not enough binder to provide adequate chip retention. From MP 29.0 to MP

It was also theorized that the loss in chips could be attributed to the variability in the underlying pavement surface. The previous year's chip seal failure resulted in some random variability in the amount of asphalt on the surface. Some segments were very rich and other areas were much leaner in residual asphalt.

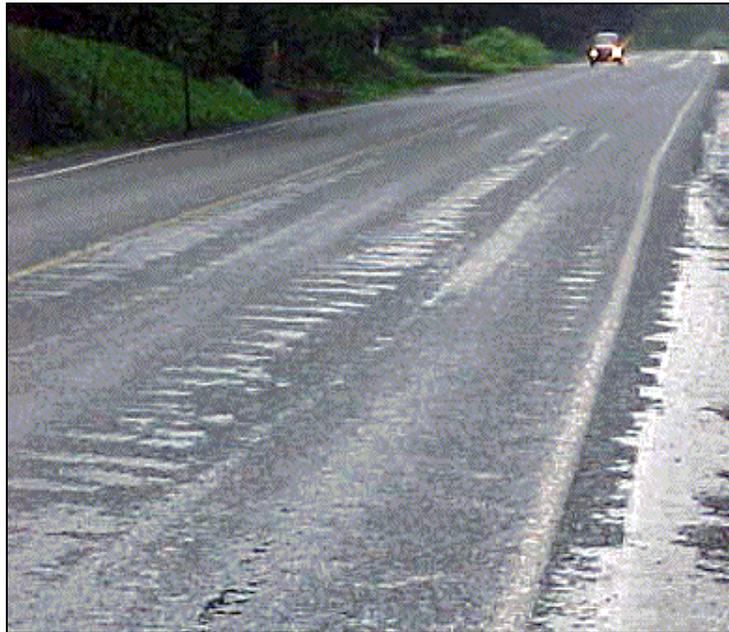
Figure 5.4: Loss of Chips Due to Snow Plow Damage at MP 31.6

In the area between MP 31.0 and MP 31.6, there was also a localized loss of chips (Figure 5.4). The chip loss was attributed to snow plow damage. The snow plow blades had peeled sections of the chip seal away in both lanes for much of the section.
